Case 460 : Narrative

Case Vehicle (A): 2003 BMW
Type: Z4, 2-door convertible
Driver: 19-year-old male
CDC: 12-FYEW-2

Case 460: Vehicle Report

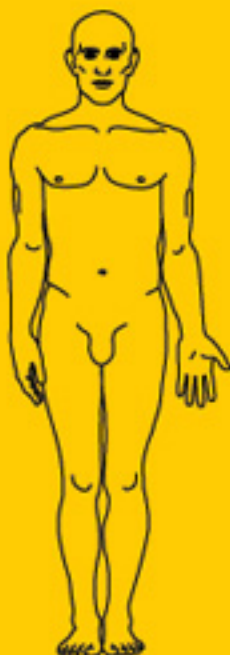
Laceration, knee
unknown aspect
(1)
